Investigation Report

ExxonMobil Torrance Refinery Electrostatic Precipitator Explosion Torrance, California

Incident Date: February 18, 2015

No. 2015-02-I-CA

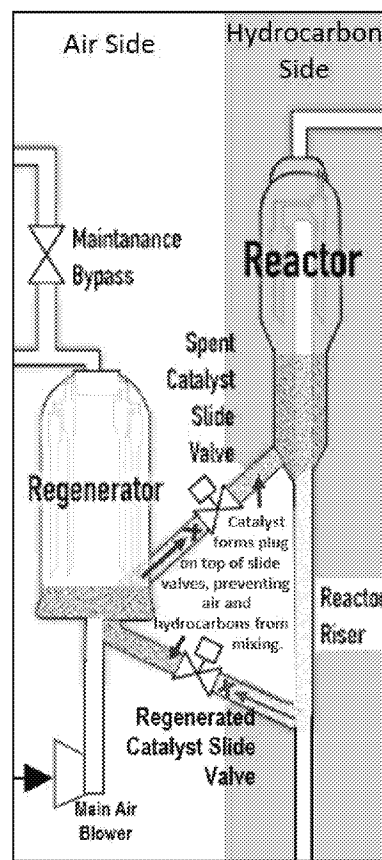
FIGURE 8

Discussed in Section 4.0, on the day of the incident, the SCSV did not maintain the catalyst plug. Hydrocarbons from the reactor flowed into the regenerator in the air side of the FCC unit, which in the Safe Park mode of operation was not sufficiently hot to burn (i.e. combust) the hydrocarbons. As a result, flammable hydrocarbons flowed to the ESP, where they mixed with air fed to the ESP from the CO boiler fans. Sparks within the ESP ignited the flammable mixture, causing an explosion.

During Safe Park, a catalyst level on top of the SCSV and RCSV is intended to prevent hydrocarbons and air from mixing.

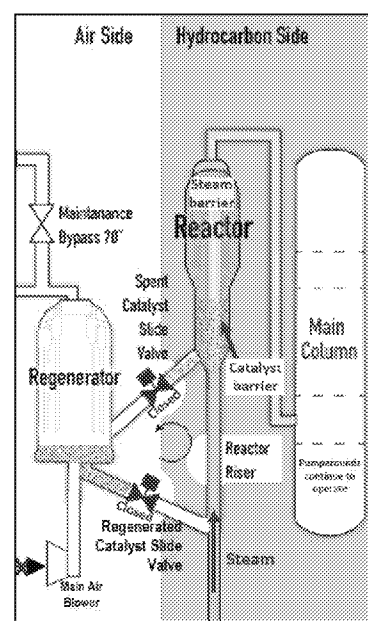
Leading to the incident, both safeguards failed, allowing hydrocarbons from the main column to enter the air side of the FCC unit.

FIGURE 12
In Safe Park configuration, the accumulated catalyst on top of the SCSV and steam pressurizing the reactor are intended to act as safeguards preventing hydrocarbons in the main column from backflowing through the reactor and to the regenerator.

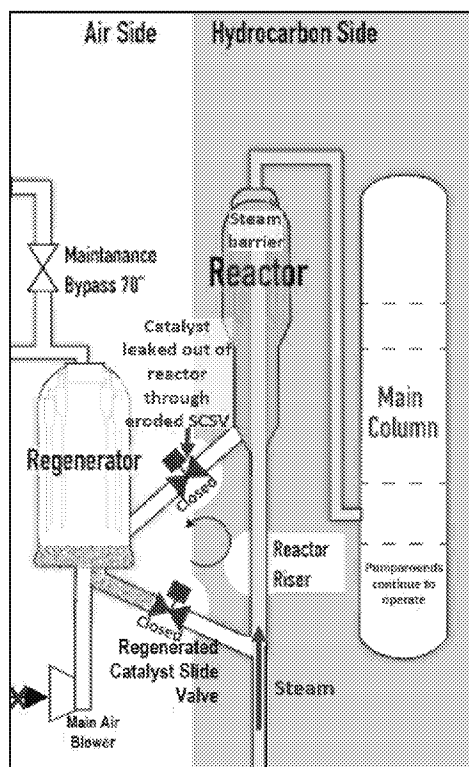
On February 16, 2015, when the FCC unit automatically transitioned to Safe Park, the control system moved both slide valves into the closed position. The SCSV, however, had severely eroded over six years of operation (see Section 5.3) and was unable to seal. As a result, within minutes after the FCC unit went into Safe Park and the SCSV closed, the catalyst particles from the reactor leaked through the SCSV and entered the regenerator (Appendix A). The SCSV safeguard failed because the damaged SCSV likely could not maintain a protective level of catalyst to isolate the reactor from the regenerator (Figure 13).

In Safe Park, the catalyst leaked through the closed SCSV, which was severely eroded from six years of operation and did not form a catalyst seal.

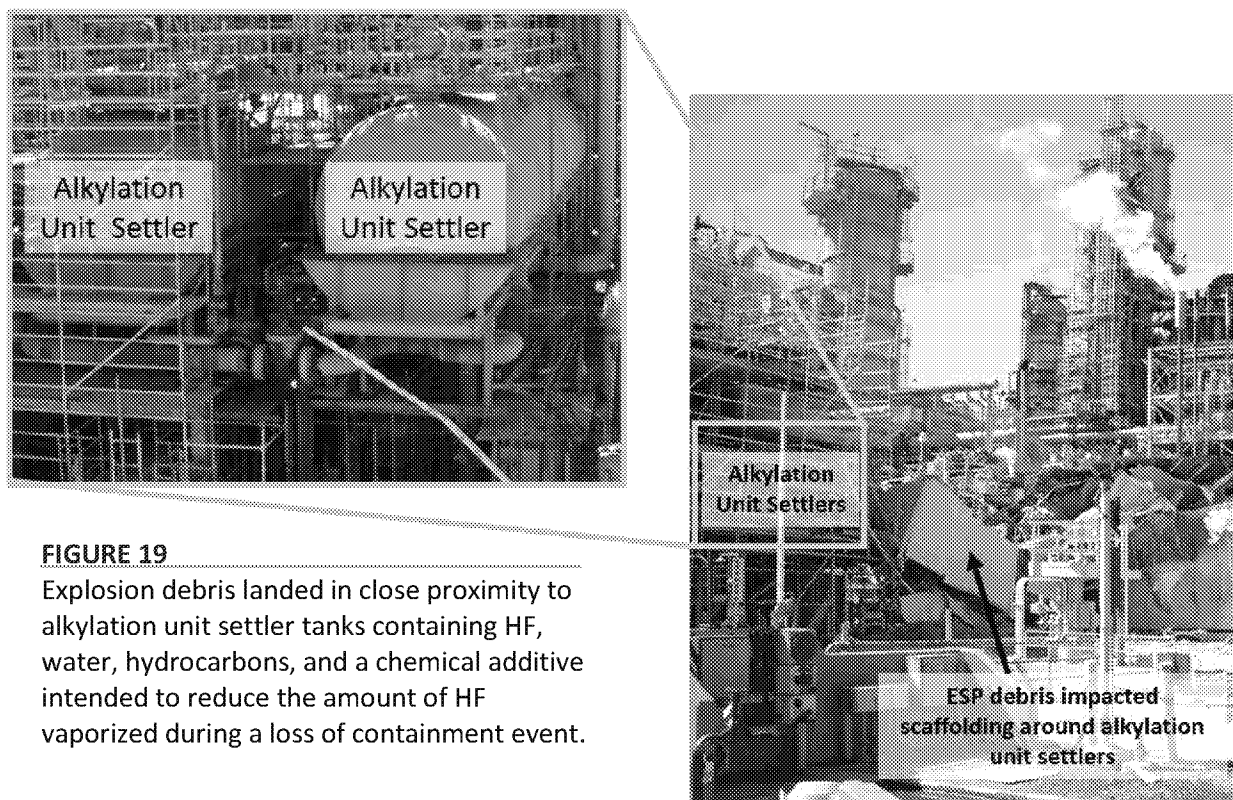
FIGURE 19

A large piece of debris from the explosion fell on scaffolding³⁸ around two settler tanks, each containing hydrofluoric acid (HF), water, hydrocarbons, and a chemical additive intended to reduce the amount of HF vaporized during a loss of containment event³⁹ (Figure 19). Pure HF is a highly toxic chemical that can seriously injure or cause death at a concentration of 30 ppm.⁴⁰ ExxonMobil resisted CSB requests for safety information pertaining to the potential release of HF in the event the tanks were struck by explosion debris. ExxonMobil continues to refuse to provide the CSB with information detailing safeguards to prevent or mitigate a release of HF. The CSB has issued subpoenas for this information, and is pursuing enforcement in US Federal district court.⁴¹

Explosion debris landed in close proximity to alkylation unit settler tanks containing HF, water, hydrocarbons, and a chemical additive intended to reduce the amount of HF vaporized during a loss of containment event.

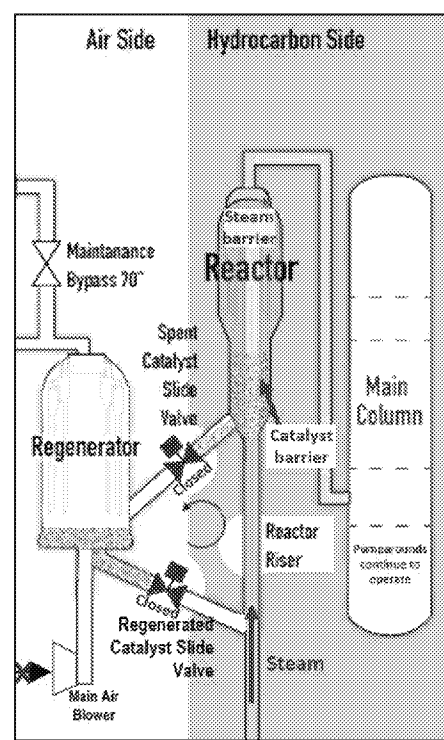
In this scenario, using a single block and bleed to isolate equipment for a confined space entry was not consistent with standard ExxonMobil safety policies. As previously discussed, ExxonMobil allows deviation from safety policies as long

FIGURE 20
Safeguards specified in 2012 Variance

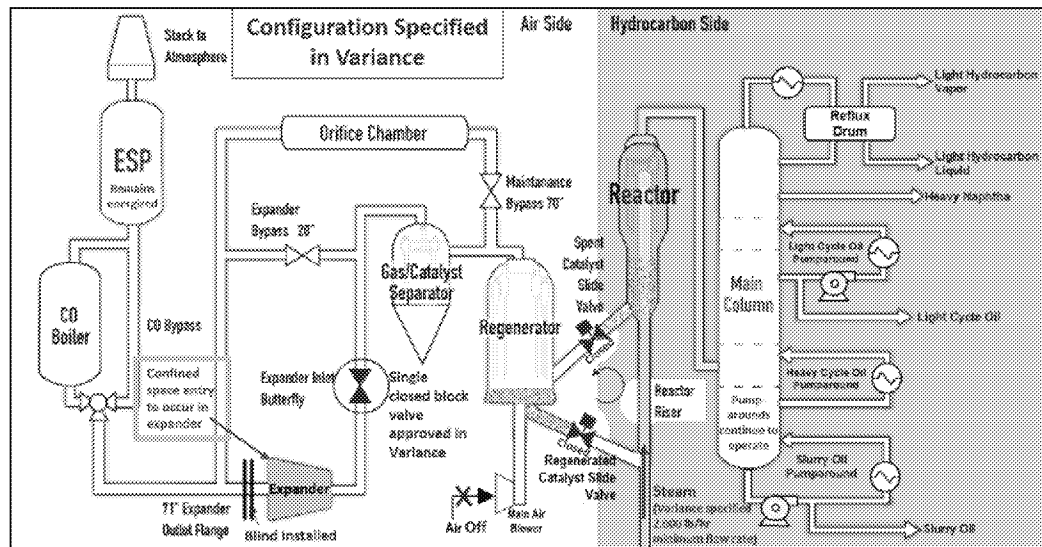
FIGURE 22

Equipment configuration specified in 2012 Variance

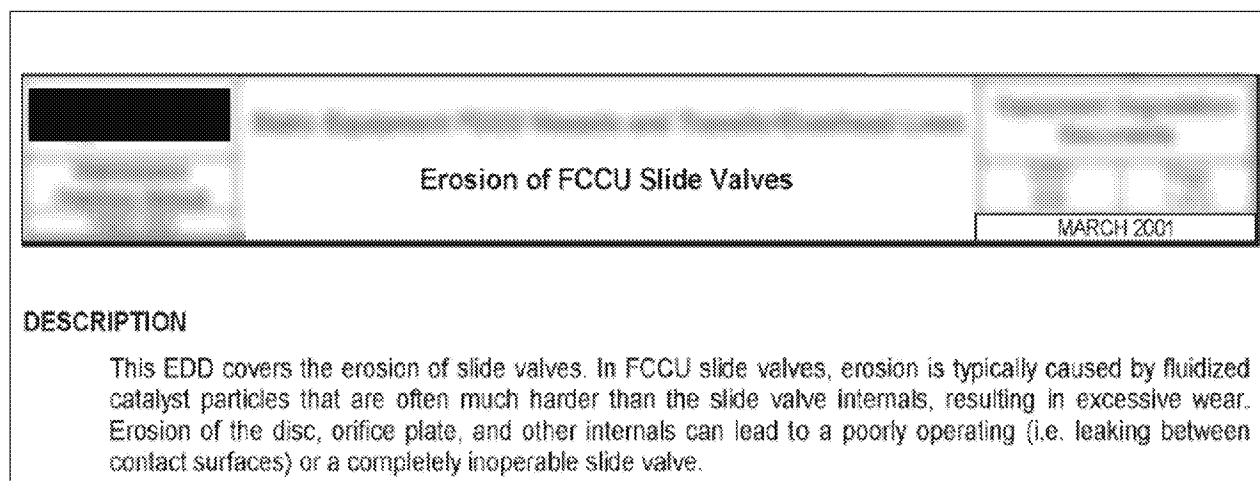
The SCSV operates in a severely erosive service. The continuous flow of abrasive fluidized catalyst particles during normal operation erodes the slide valve internals, which can prevent the valve disc from sealing. ExxonMobil repaired the SCSV internals during turnarounds in 2000, 2004, and 2009 because the valve had eroded. An ExxonMobil “Equipment Degradation Document” details the likelihood of SCSV inability to seal due to erosion of the valve (Figure 24).

FIGURE 24
ExxonMobil Equipment Degradation Document

The Equipment Degradation Document predicts the probability of failure of the SCSV due to erosion, based upon a four- to five-year run length of the FCC unit between turnarounds. To ensure effective operability of the valve, ExxonMobil assigned it a testing interval of every four years to make sure the valve could function as required to prevent a flow reversal during normal operation. To meet the four-year testing requirement, ExxonMobil periodically partially closed the SCSV while the unit operated to verify that the mechanical valve components functioned properly. While an important mechanical testing strategy, this testing method did not evaluate whether the valve was eroded, or test whether the SCSV could close and seal. ExxonMobil therefore relied on the

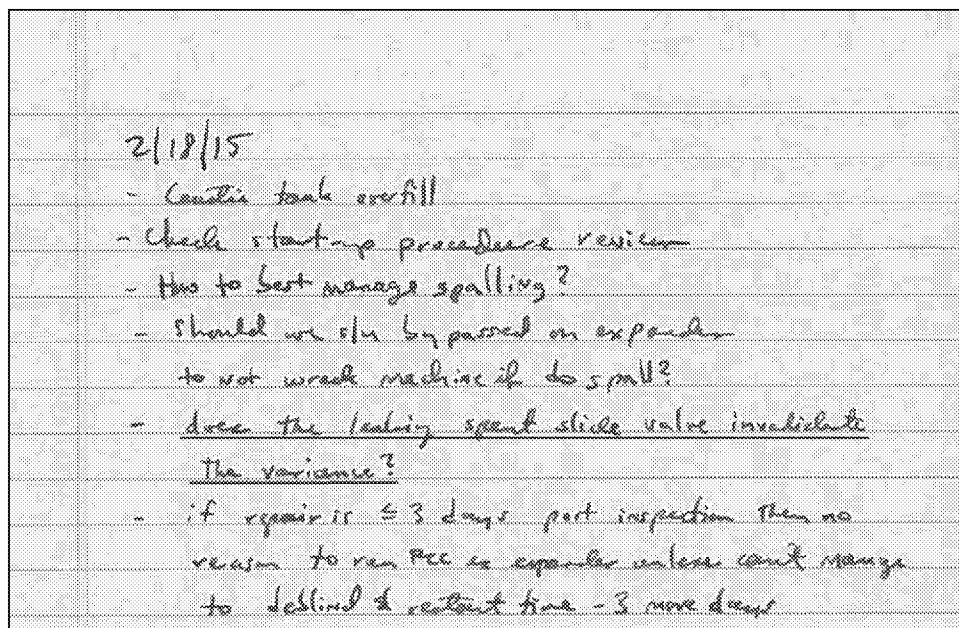
FIGURE 26

ExxonMobil management knew the SCSV was leaking leading up to the incident. Notes from meetings of management personnel questioning “Does the leaking spent slide valve invalidate the variance?” (Figure 26) and CSB interviews demonstrate that managers knew and discussed that the SCSV was leaking on the day of the incident. The catalyst level in the reactor—showing zero level—was displayed on the FCC unit console, measurements of high temperature downstream of the slide valve indicated that steam was leaking through the slide valve, and steam was visually observed leaking from multiple locations on the air side of the FCC unit.

Notes from day of incident show that ExxonMobil knew of leaking SCSV. (emphasis added)

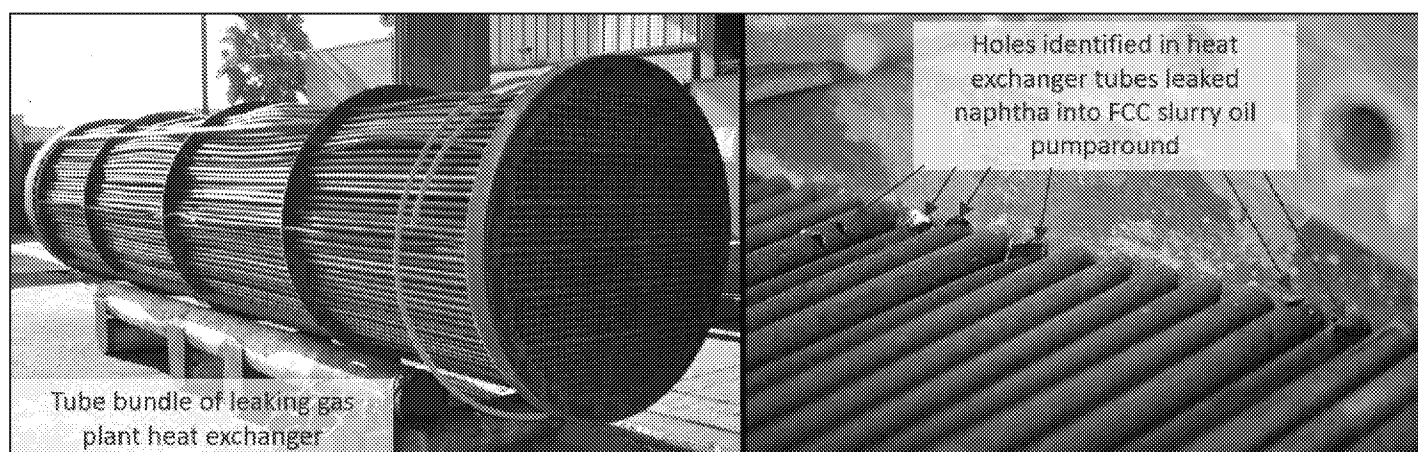
FIGURE 29

In 2015, the column pressure had increased because a heat exchanger—that had an extended operation—on the slurry oil pumparound loop was leaking naphtha into the slurry oil (Figure 28 and Figure 29). The high temperature of the slurry oil vaporized the more volatile naphtha, which increased the pressure of the main column.

Post-incident photos of heat exchanger tube bundle that leaked naphtha into main column slurry oil pumparound

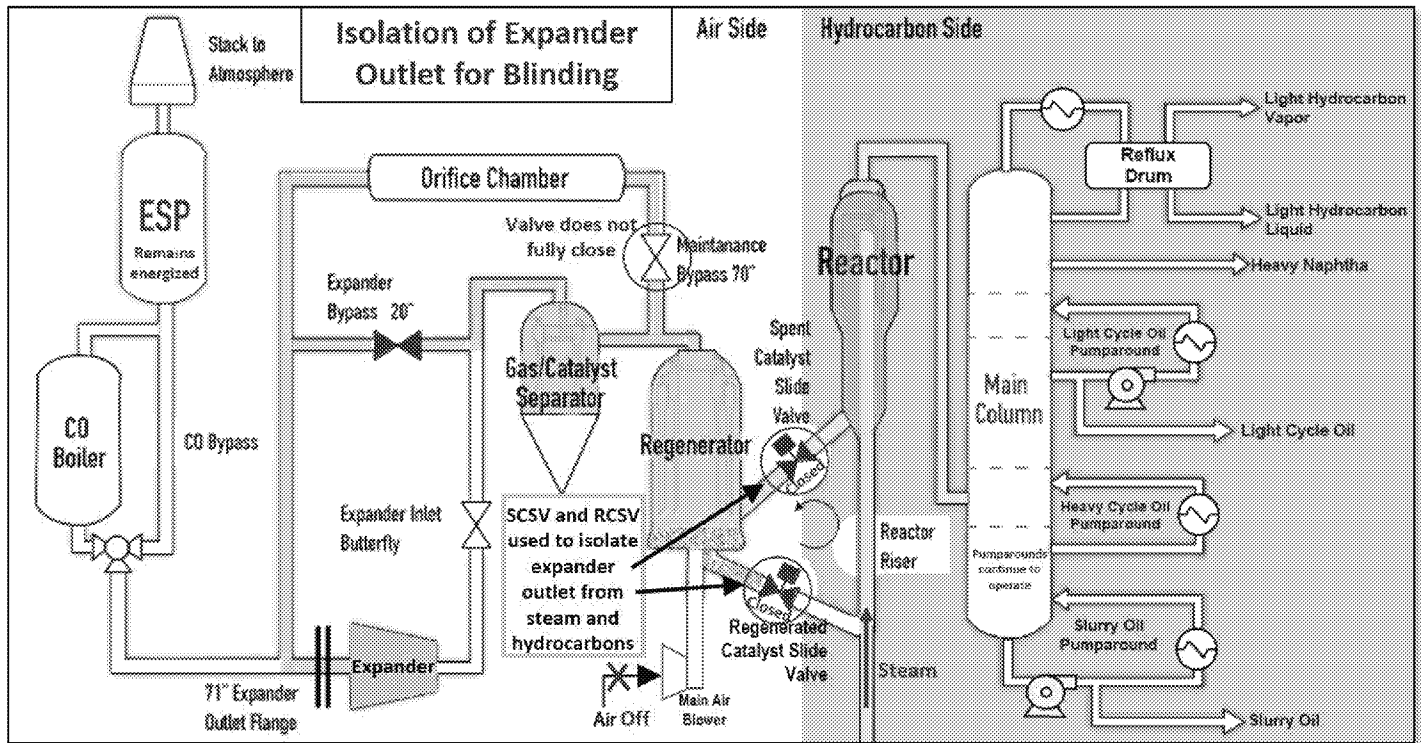
The piping leading to the expander outlet flange was not designed to allow double block and bleeding. The maintenance bypass valve shown in Figure 34 could not be used to isolate the expander from the process because it had a hole designed into it for overpressure protection purposes.⁵⁴ ExxonMobil, therefore, had to perform a single block and bleed to isolate the expander from the process. The only valves available to isolate the expander outlet from process fluids (steam and hydrocarbons) were the SCSV and RCSV. These valves, however, are control valves that throttle the flow of catalyst. ExxonMobil does not consider control valves to be energy isolation devices that can be used to isolate equipment for opening (Figure 33). Control valves typically should not be used as block valves because fluid flow through a partially open control valve can cause damage to the valve that can limit its ability to fully seal. The site therefore did not comply with refinery standards when attempting to insert the blind into the expander outlet. If ExxonMobil management had adhered to the Lock Out Tag Out procedure, they would not have been able to use the SCSV and RCSV to isolate the expander from process fluids, and the expander outlet flange would not have been able to be opened while the unit was in Safe Park. Alternatively, ExxonMobil could have developed a Variance to depart from the typical safety practice and conducted a detailed hazard evaluation to evaluate the safety of the proposed isolation strategy. ExxonMobil did not, however, develop a Variance for this operation. In this instance, opening the expander outlet flange led to the decision to reduce reactor steam flow, which led to the ESP explosion.

FIGURE 34
Configuration used to isolate expander outlet for blinding

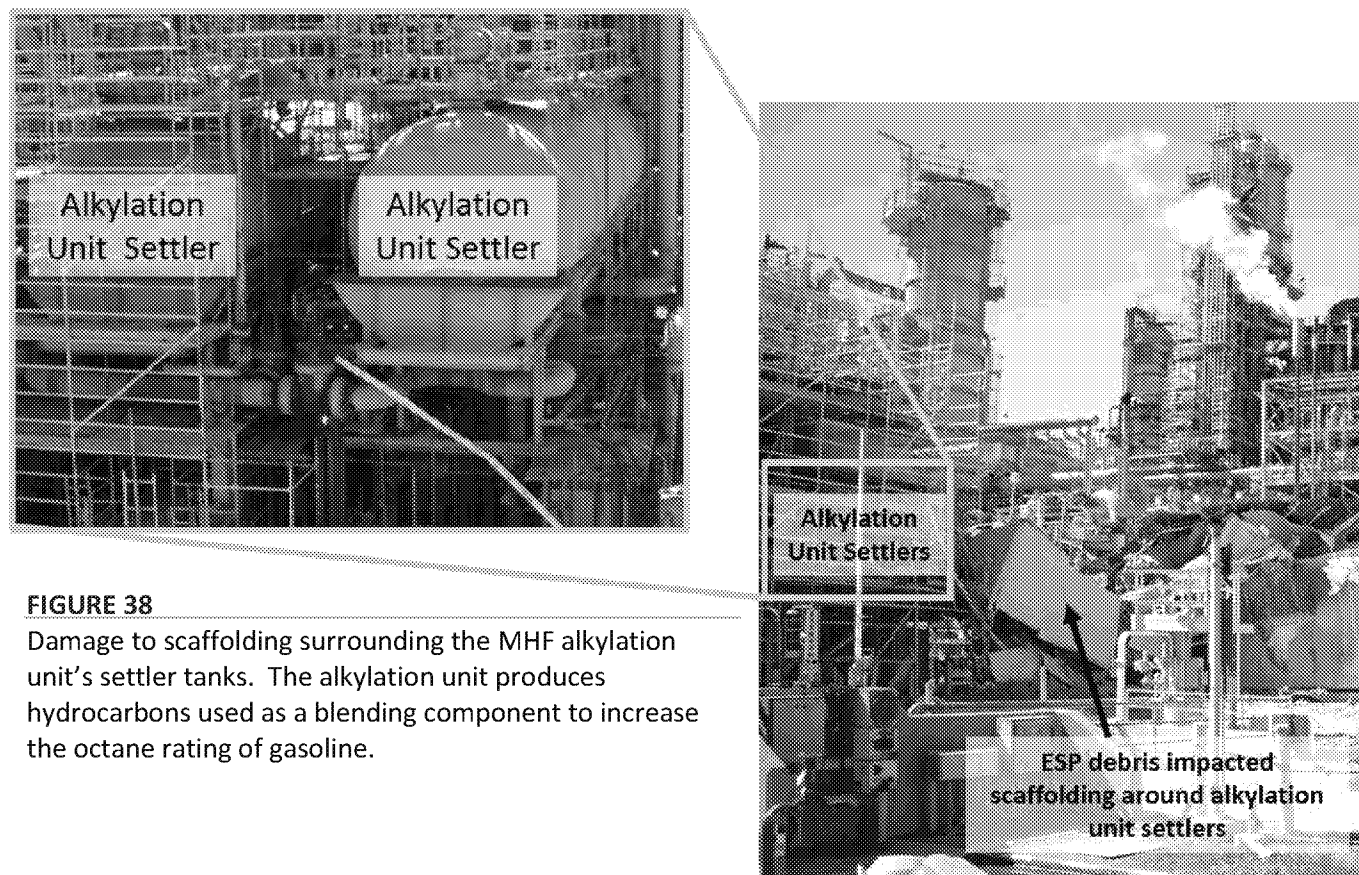
FIGURE 38

Following the ESP explosion, a portion of the ESP fell to the ground. A large fragment struck scaffolding⁵⁹ surrounding the MHF alkylation unit.⁶⁰ This scaffolding was located within a few feet of the alkylation unit's settler tanks⁶¹ (Figure 38), each containing hydrofluoric acid (HF), water, hydrocarbons, and a chemical additive intended to reduce the amount of HF vaporized during a loss of containment event.⁶² Discussed previously, the CSB has issued subpoenas for safety information pertaining to the potential release of HF in the event the tanks were struck by explosion debris, and is pursuing enforcement of the subpoenas in US Federal district court.⁶³

Damage to scaffolding surrounding the MHF alkylation unit's settler tanks. The alkylation unit produces hydrocarbons used as a blending component to increase the octane rating of gasoline.

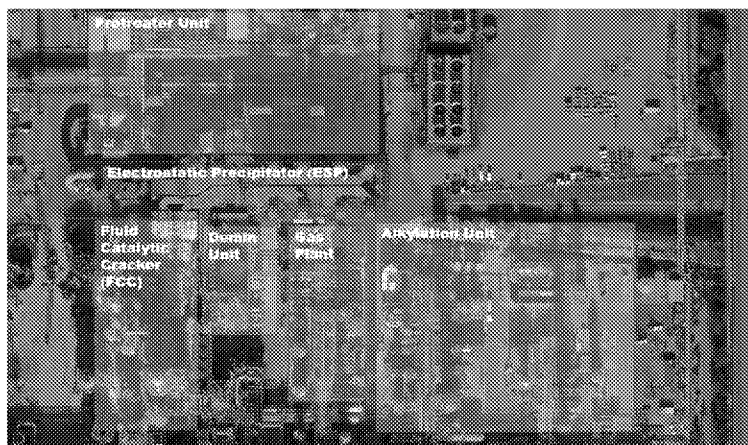
The ESP was installed in the FCC unit in 2009, to comply with new environmental regulations.⁶⁴ ExxonMobil constructed the ESP adjacent to the FCC unit and in close proximity to other units (Figure 39). For example, the distance from the ESP to the alkylation unit is approximately 80 feet. From the ESP to the Pretreater Unit⁶⁵ is less than 50 feet. And from the ESP to the Demineralization Unit, located directly south of the ESP, is also less than 50 feet away.

FIGURE 39
Overhead view of a portion of the Torrance refinery

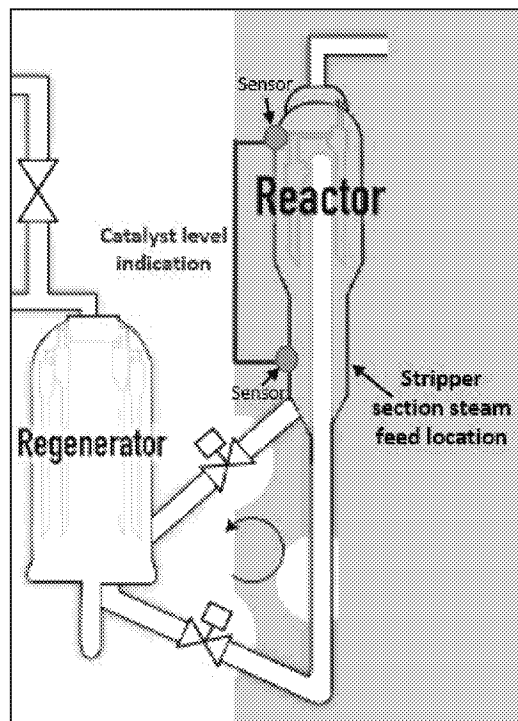
At the Torrance refinery, the level of the fluidized catalyst bed in the reactor is measured, using the two sensors shown in Figure A-1. During normal operation and during Safe Park, the catalyst in the reactor is fluidized by steam fed to the reactor stripping section. The fluidizing steam feed location is also shown in Figure A-1.

In both the 2012 and 2015 transitions to Safe Park, when the Spent Catalyst Slide Valve (SCSV) closed, the reactor catalyst level fell below the bottom sensor shown in Figure A-1. In 2012, it took 20 minutes for the catalyst level to fall below the bottom sensor, and in 2015 it took 9 minutes (see Figure A-2). This likely indicates that the fully closed SCSV was leaking both in 2012 and 2015. The leak rate in 2015 was likely faster due to the advanced erosion of the SCSV. Industry experts have informed the CSB that SCSVs may leak, even when the SCSV is new and has not been eroded by catalyst.

FIGURE A-1
Reactor catalyst bed level measurement

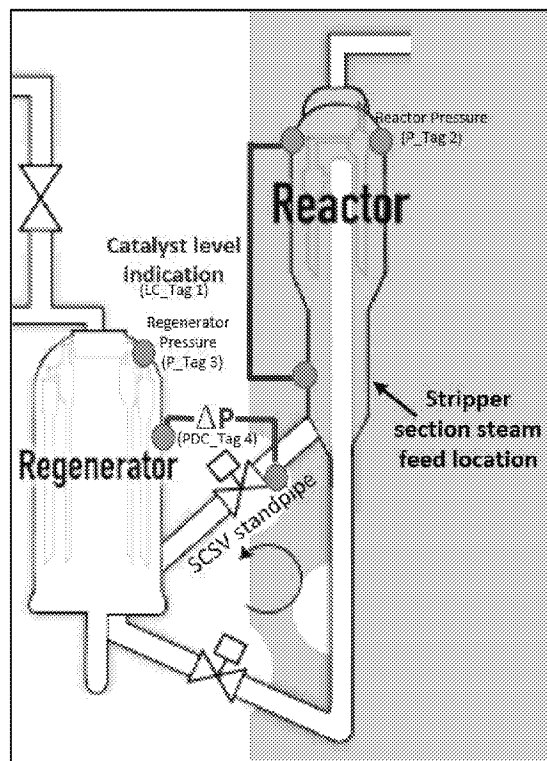
ExxonMobil measured the reactor pressure (**P_Tag 2** shown in Figures A-3, A-4, A-5) and regenerator pressure (**P_Tag 3** in Figures A-3, A-4, A-5) in addition to the SCSV standpipe/regenerator differential pressure (**PDC_Tag 4** in Figures A-3, A-4, A-5). In 2012, the measured SCSV standpipe/regenerator differential pressure (**PDC_Tag 4**) was approximately 5 psi greater than the calculated pressure difference between the reactor and regenerator (**P_Tag 2** minus **P_Tag 3**) (Figure A-4). In 2012, ExxonMobil engineers compared the **PDC_Tag 4** differential pressure indicator reading to the calculated pressure difference between the reactor pressure and the regenerator pressure (**P_Tag 2** minus **P_Tag 3**). They identified the 5 psi pressure difference, and concluded that a catalyst level had developed above the closed SCSV and was exerting 5 psi of pressure, providing a barrier between the reactor and regenerator.

FIGURE A-3
SCSV standpipe / regenerator differential pressure instrument used to determine catalyst level above closed SCSV

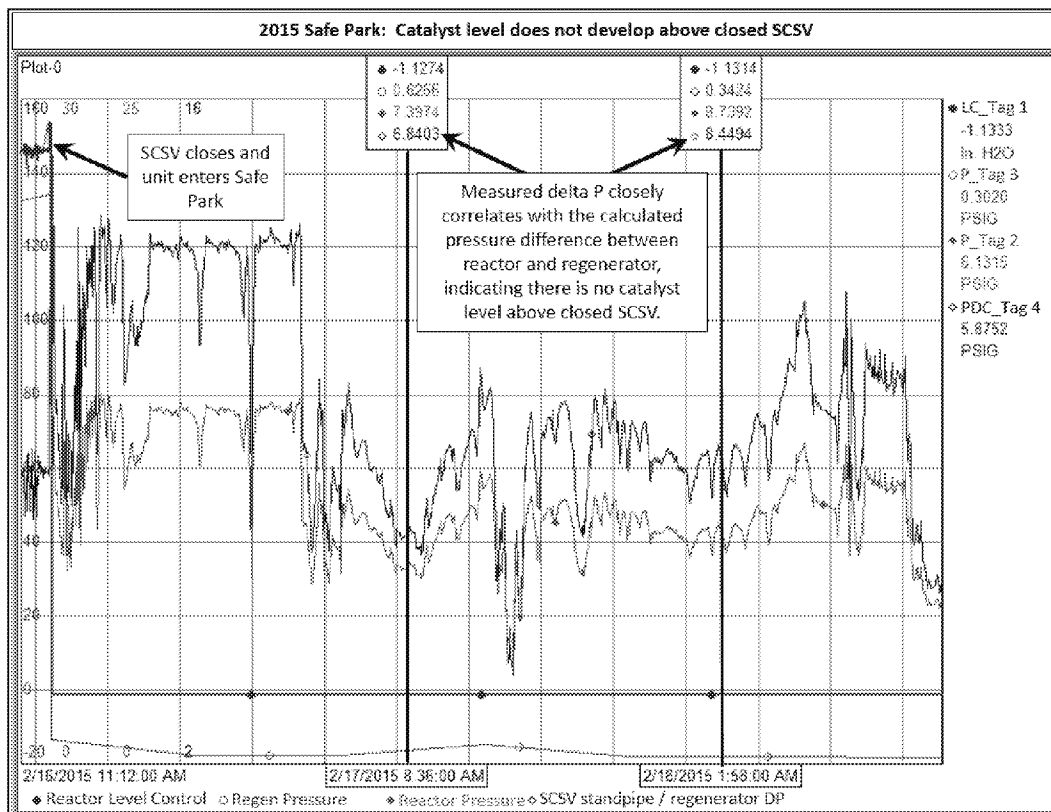
FIGURE A-5

In 2015, the measured SCSV standpipe/regenerator differential pressure closely correlated with the calculated pressure difference between the reactor and the regenerator (Figure A-5). This could have served as an indication that a catalyst level had not developed on top of the closed SCSV, meaning that the anticipated catalyst safeguard was not available. ExxonMobil refinery management, however, did not monitor the **PDC_Tag 4** differential pressure reading during preparation to enter the expander during the days leading to the incident, and this important information was not analyzed or considered prior to the incident.

In 2015, measured SCSV standpipe/regenerator differential pressure closely matched the calculated reactor/regenerator differential pressure, indicating that catalyst had not accumulated above the closed SCSV.
